**RCRA SITE SCREENING INSPECTION REPORT**  
**Enforcement Confidential – Deliberative Process**

SITE NAME: Canton Drop Forge  
EPA ID NUMBER: OHD004465142  
ADDRESS: 4575 Southway Street S.W.  
Canton, Ohio 44706  
DATE OF INSPECTION: July 1, 2011  
EPA INSPECTOR: Michael Beedle

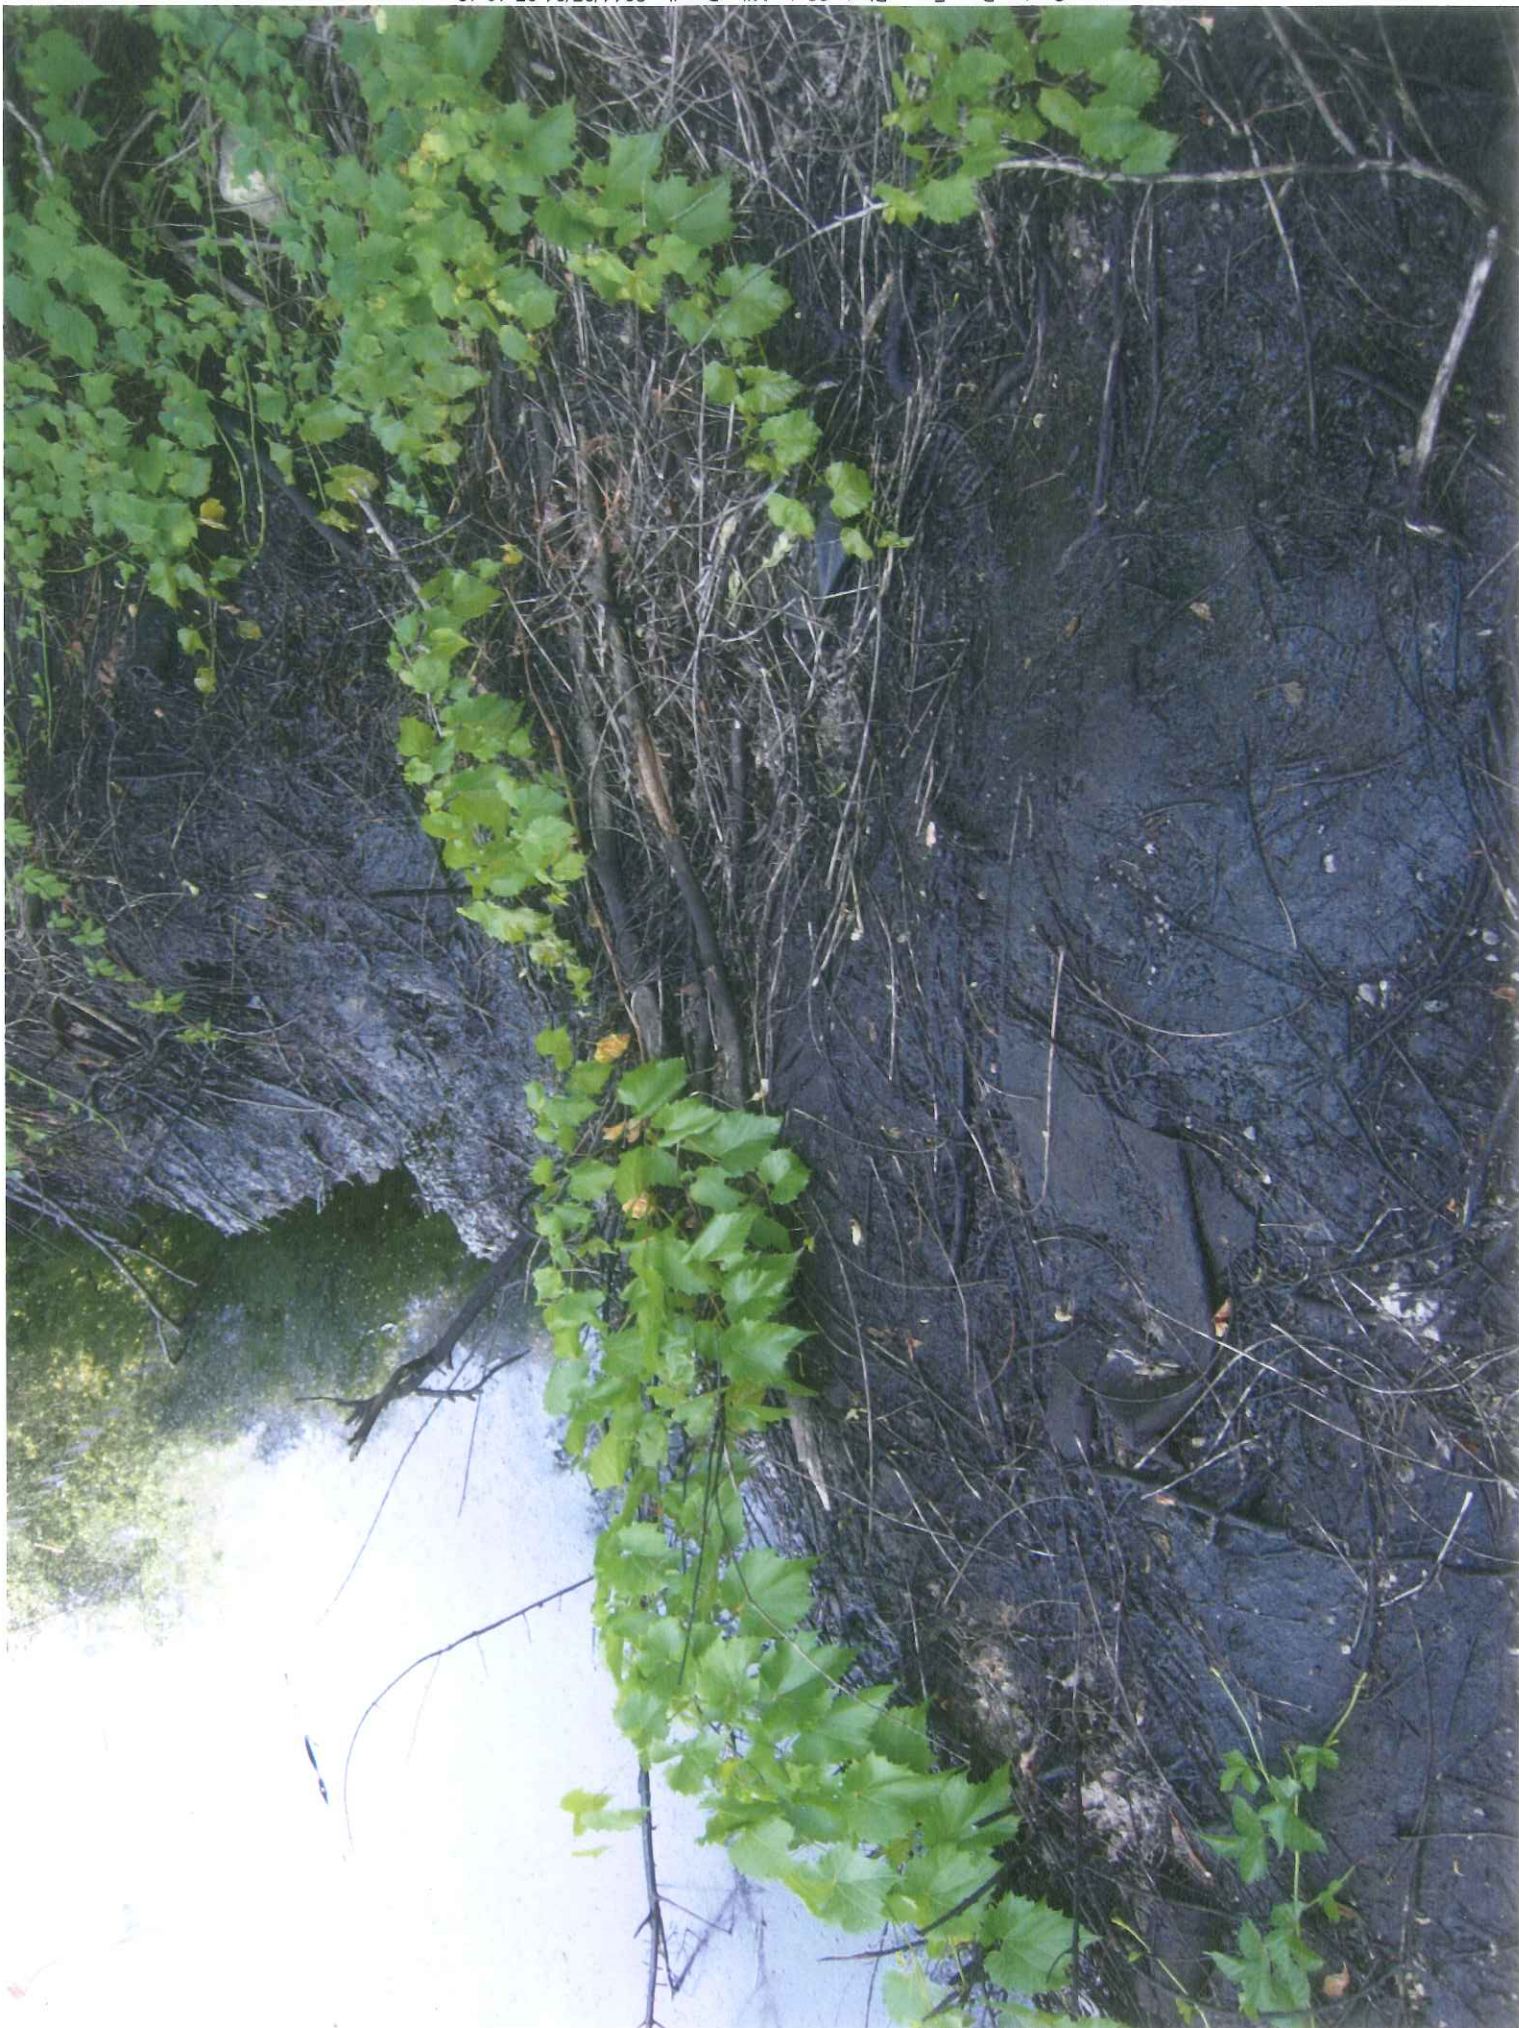
Canton Drop Forge Photo 22, by Mike Beedle, 2011/07/01 07:46:42

| Photo | Description |
|---|--|
| 22 | North bank of Pond 2. Heavily oiled stained. Dead vegetation. |

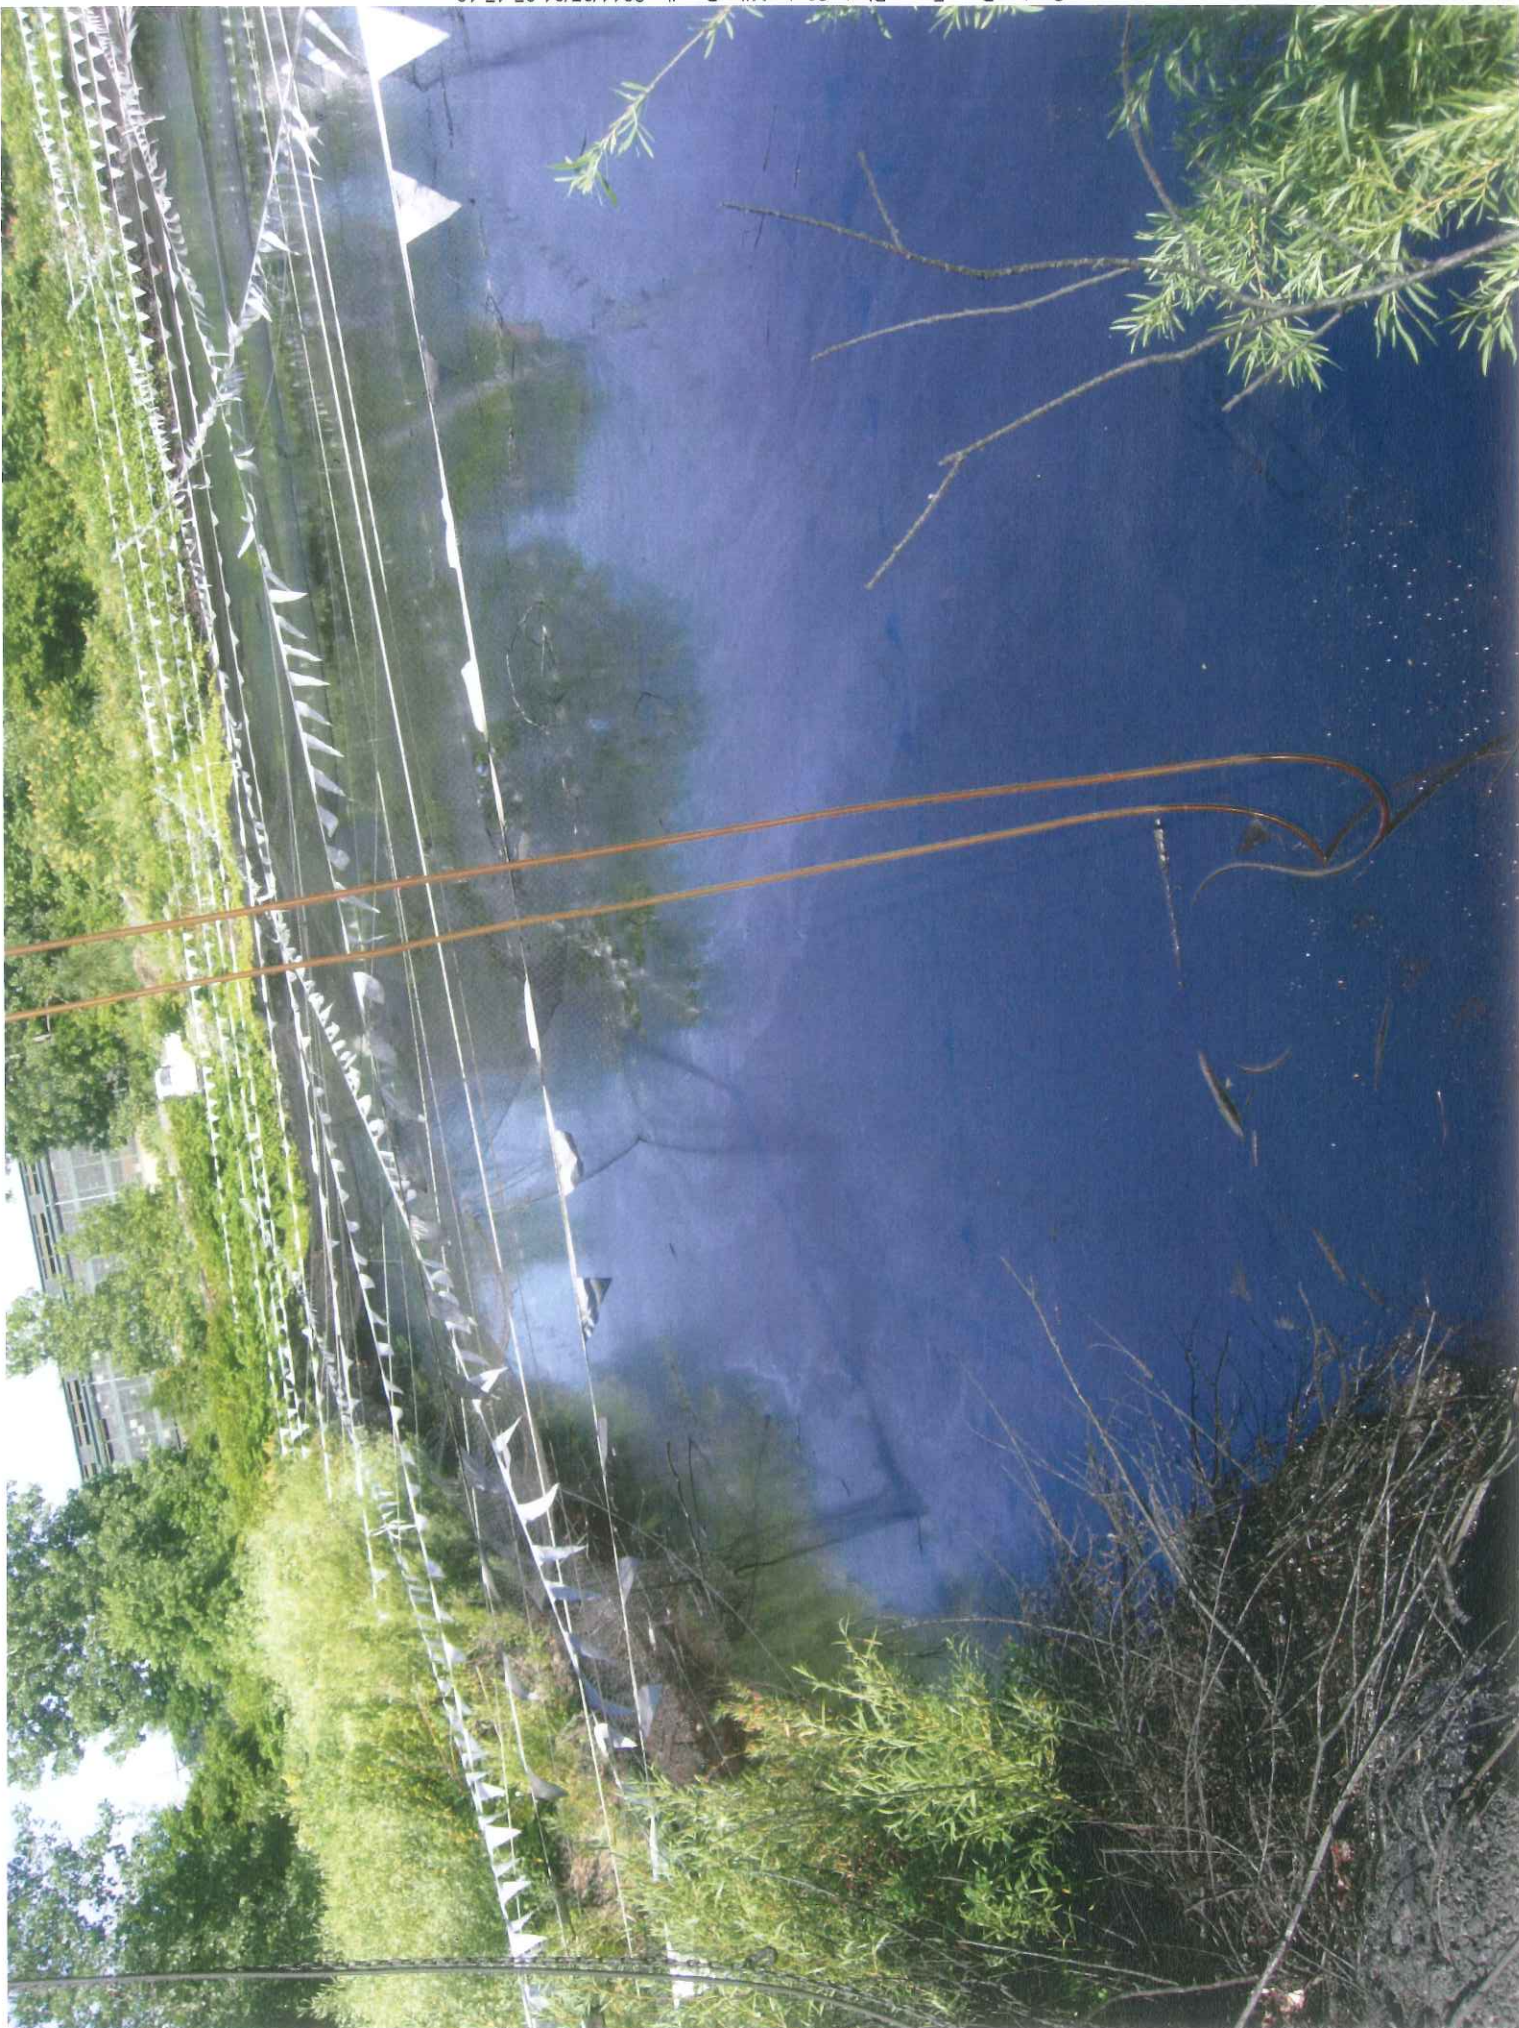
Canton Drop Forge Photo 23, by Mike Beedle, 2011/07/01 07:47:13

| Photo | Description |
|---|--|
| 23 | Rope skimmer in Pond 2. |

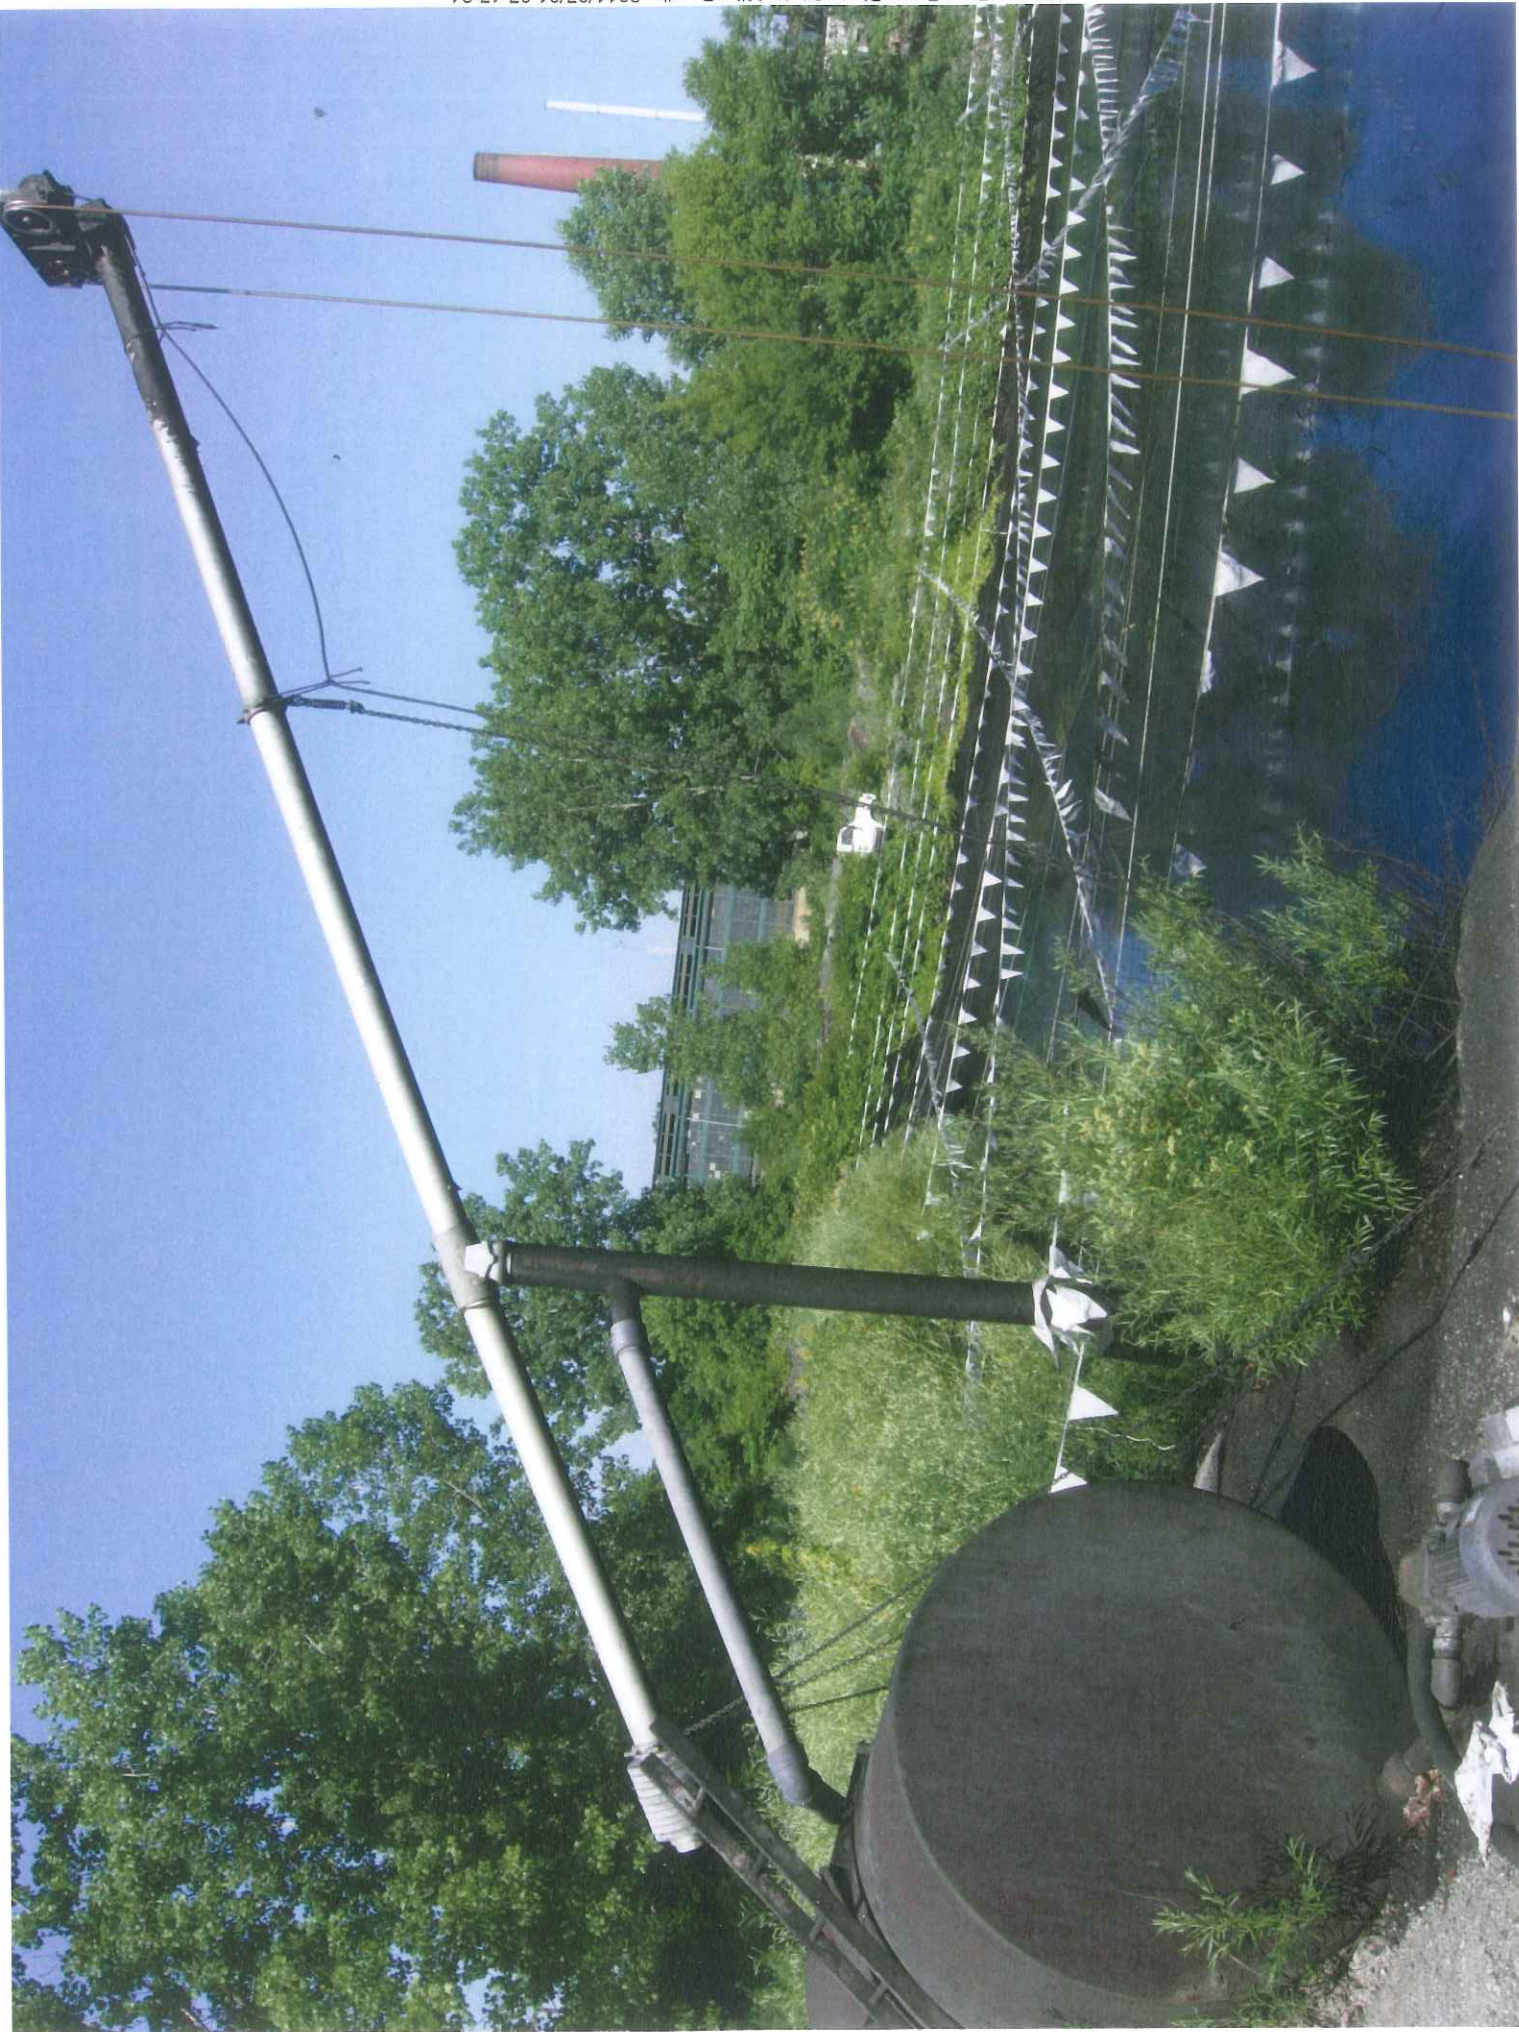
Canton Drop Forge Photo 24, by Mike Beedle, 2011/07/01 07:47:24

associated with the skimming. The tanks were not labeled or marked used oil. Mr. Houseknecht said the skimmer is run occasionally. Pond 2 is pumped to Pond 3.

| Photo | Description |
|---|--|
| 24 | Tank and rope skimmer apparatus at Pond 2. |

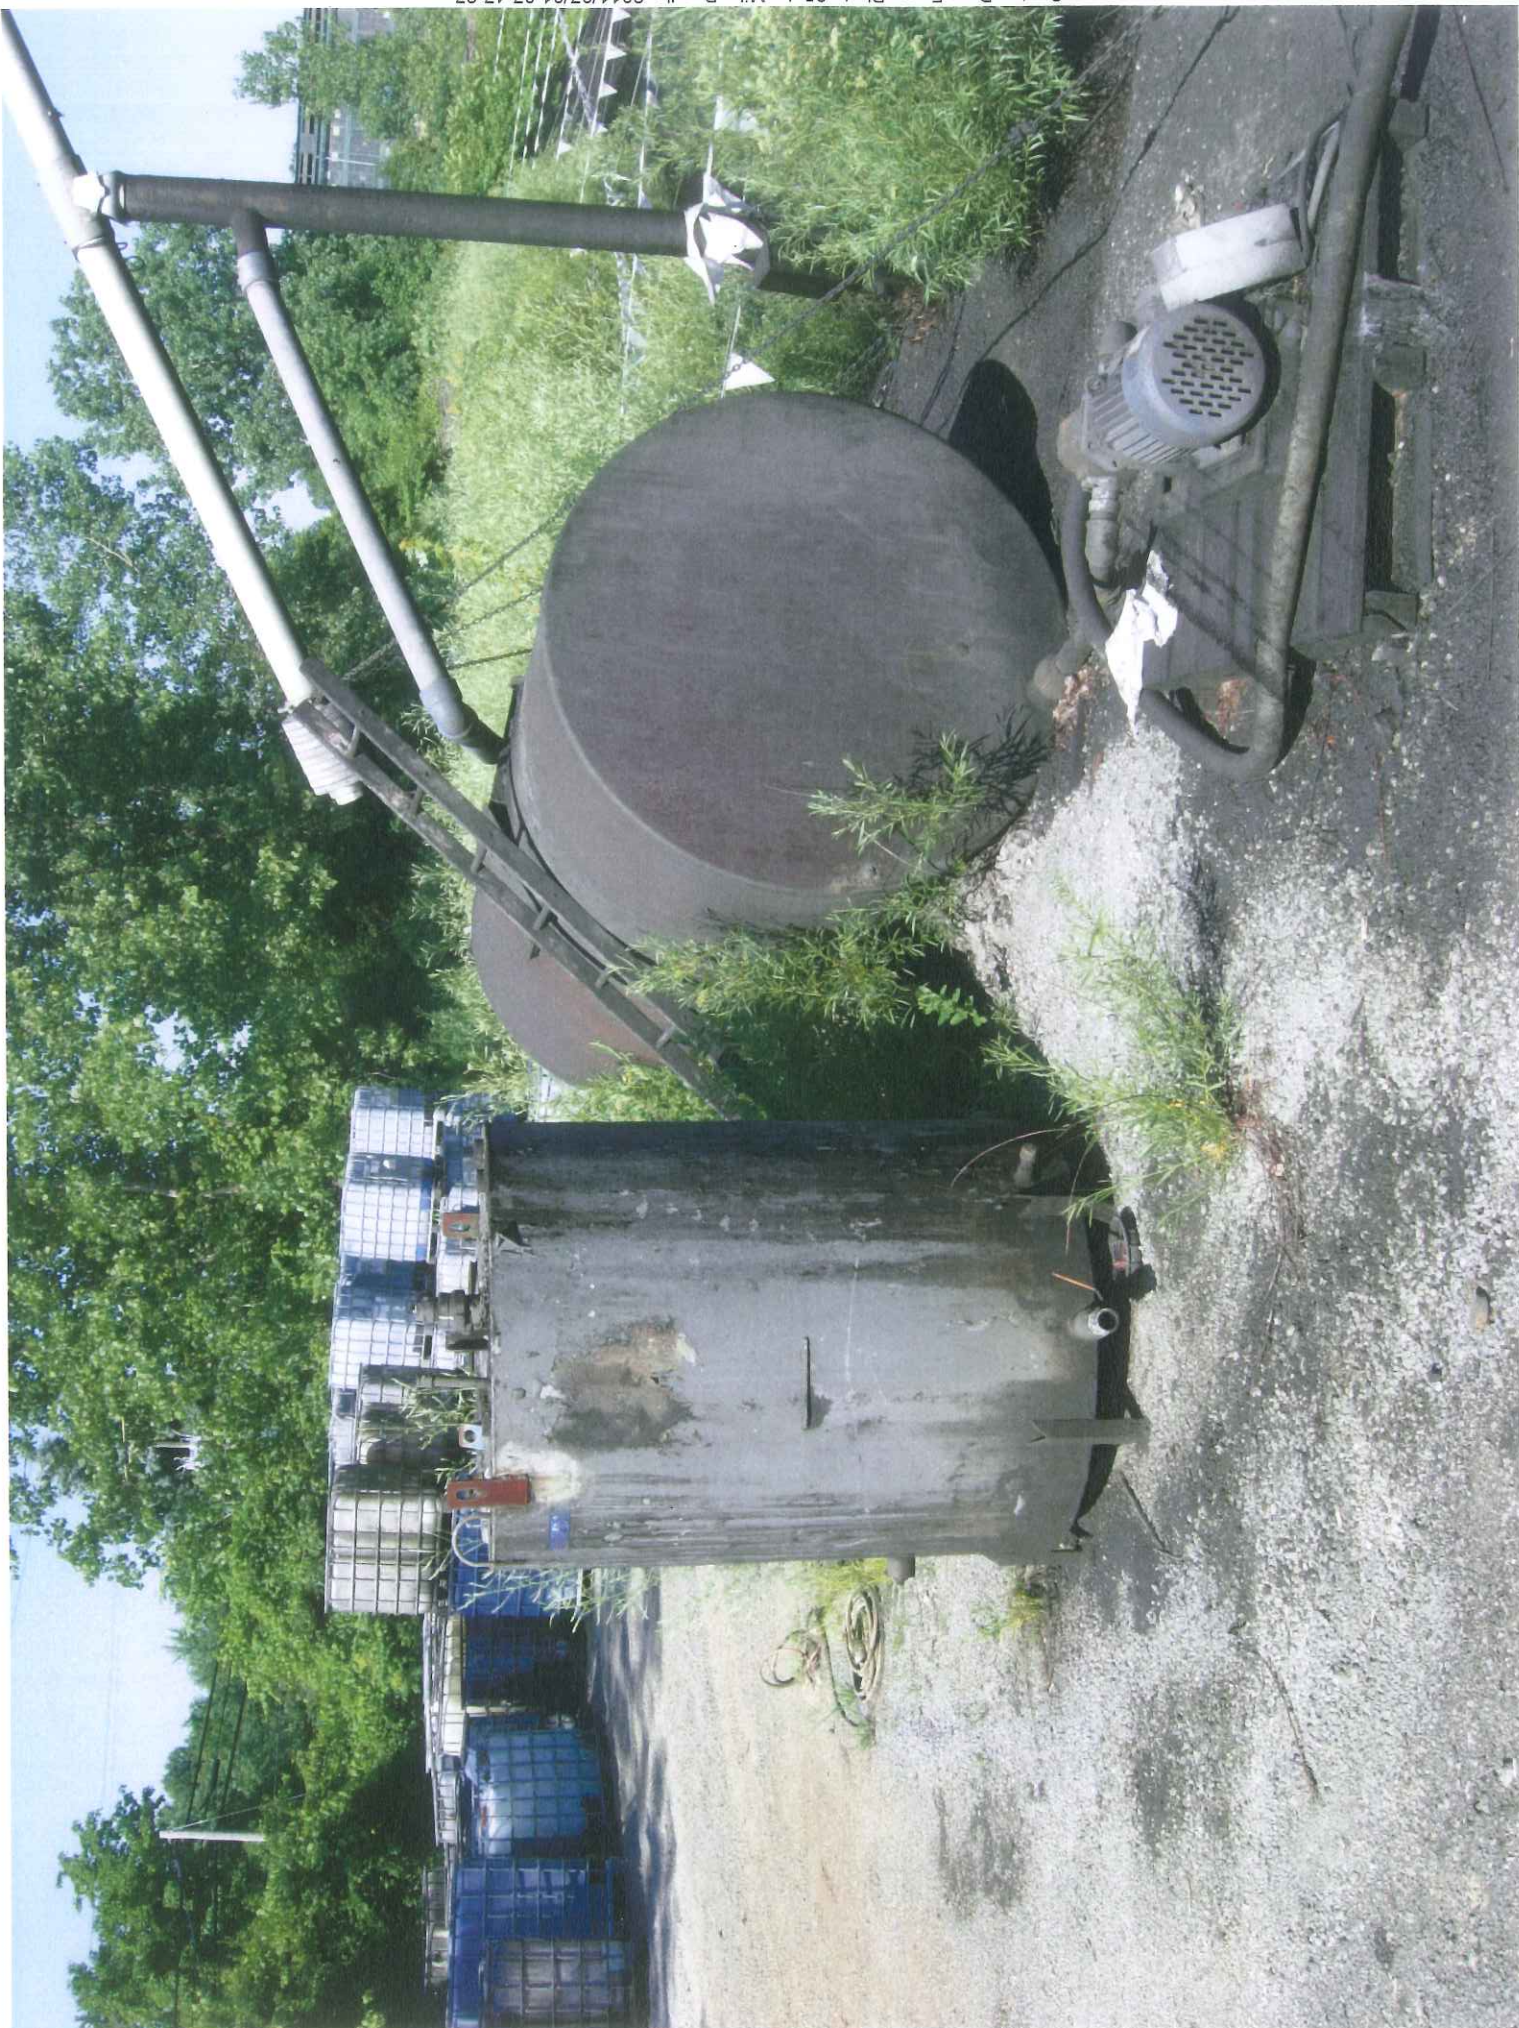
| Photo | Description |
|---|--|
| 25 | Two tanks at Pond 2, southeast corner. |

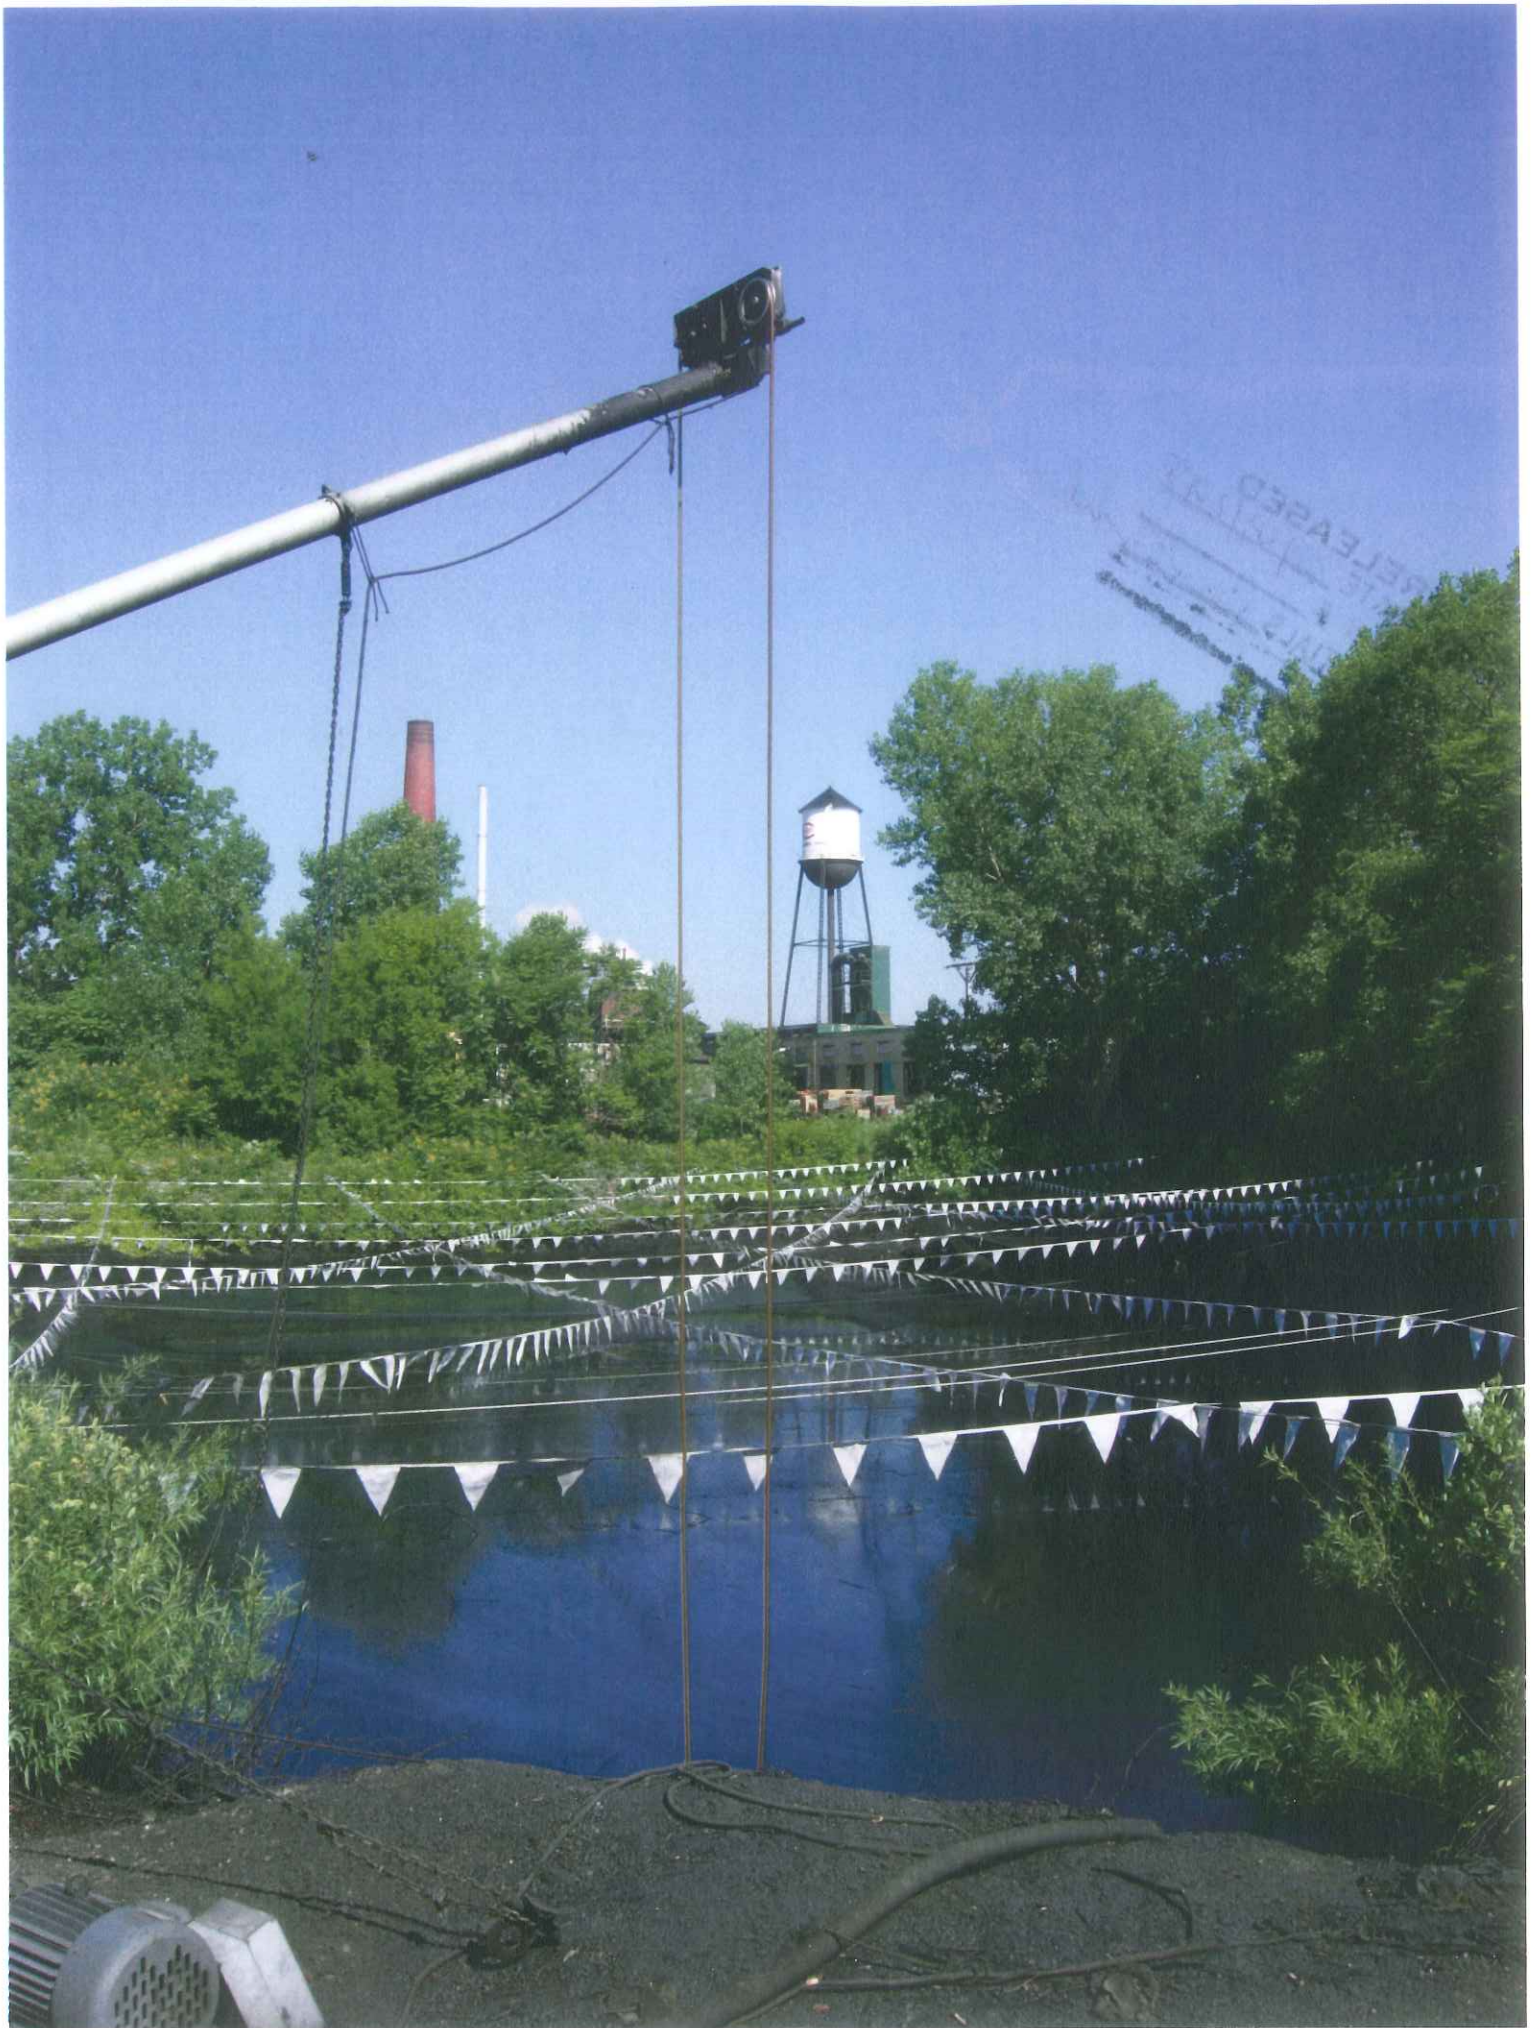
Canton Drop Forge Photo 26, by Mike Beedle ,2011/07/01 07:47:34

| Photo | Description |
|---|--|
| 26 | Rope skimmer, SE corner of Pond 2. |

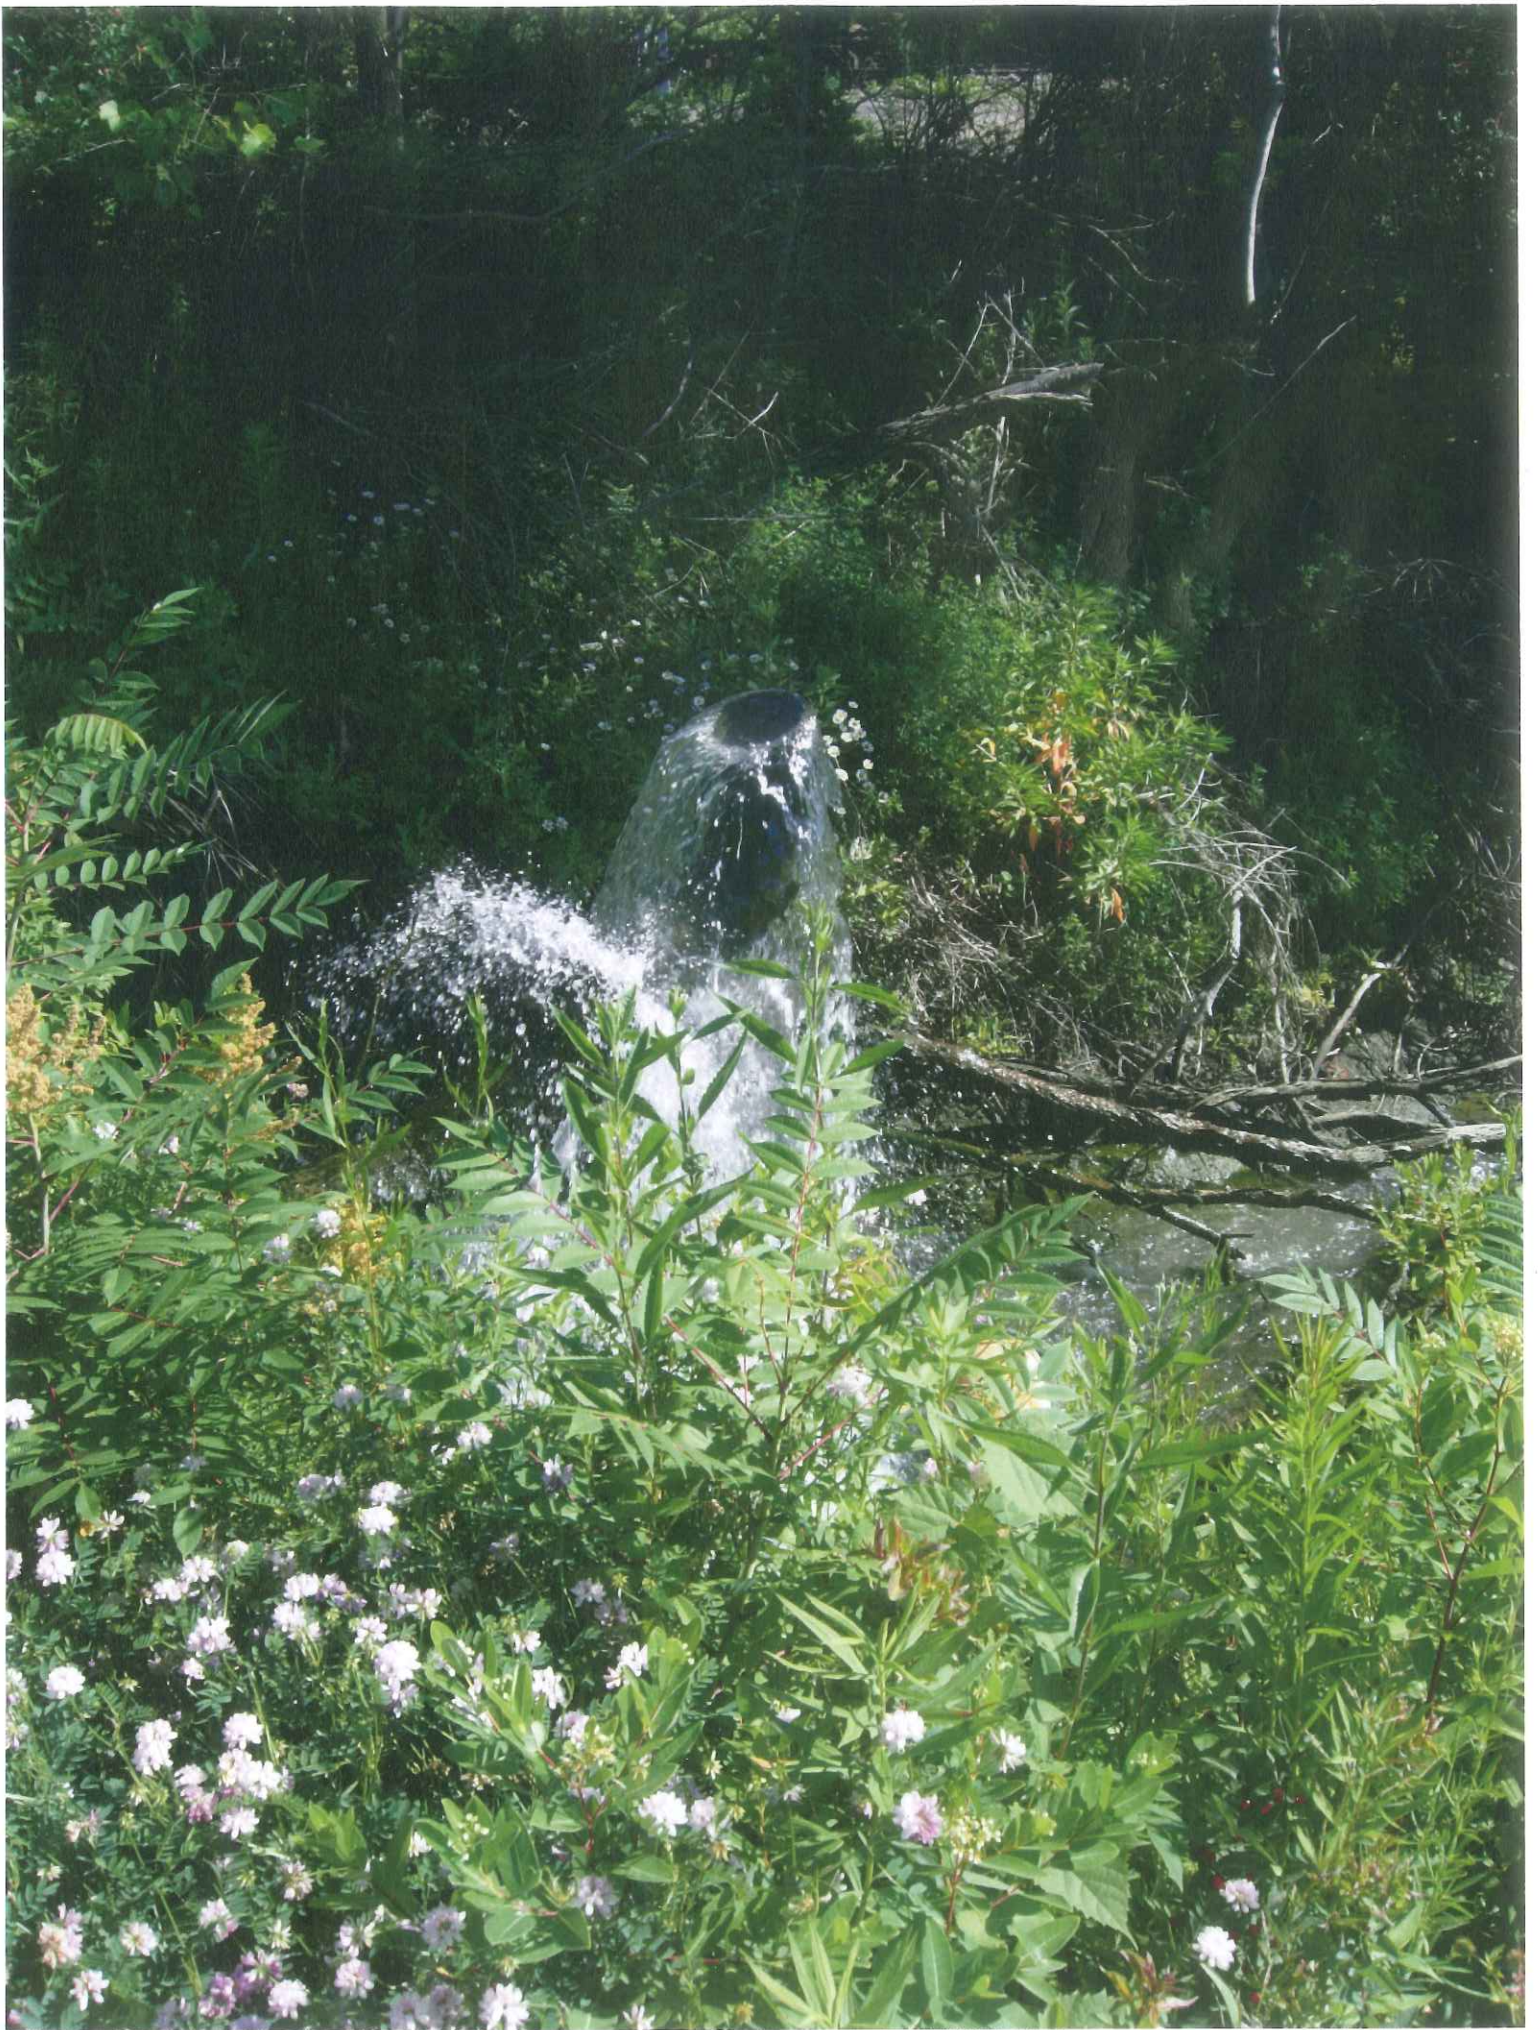
Canton Drop Forge Photo 27, by Mike Beedle, 2011/07/01 07:49:53

| Photo | Description |
|---|--|
| 27 | Pond 3, where water is received from Pond 2. Northwest corner of Pond 3. |

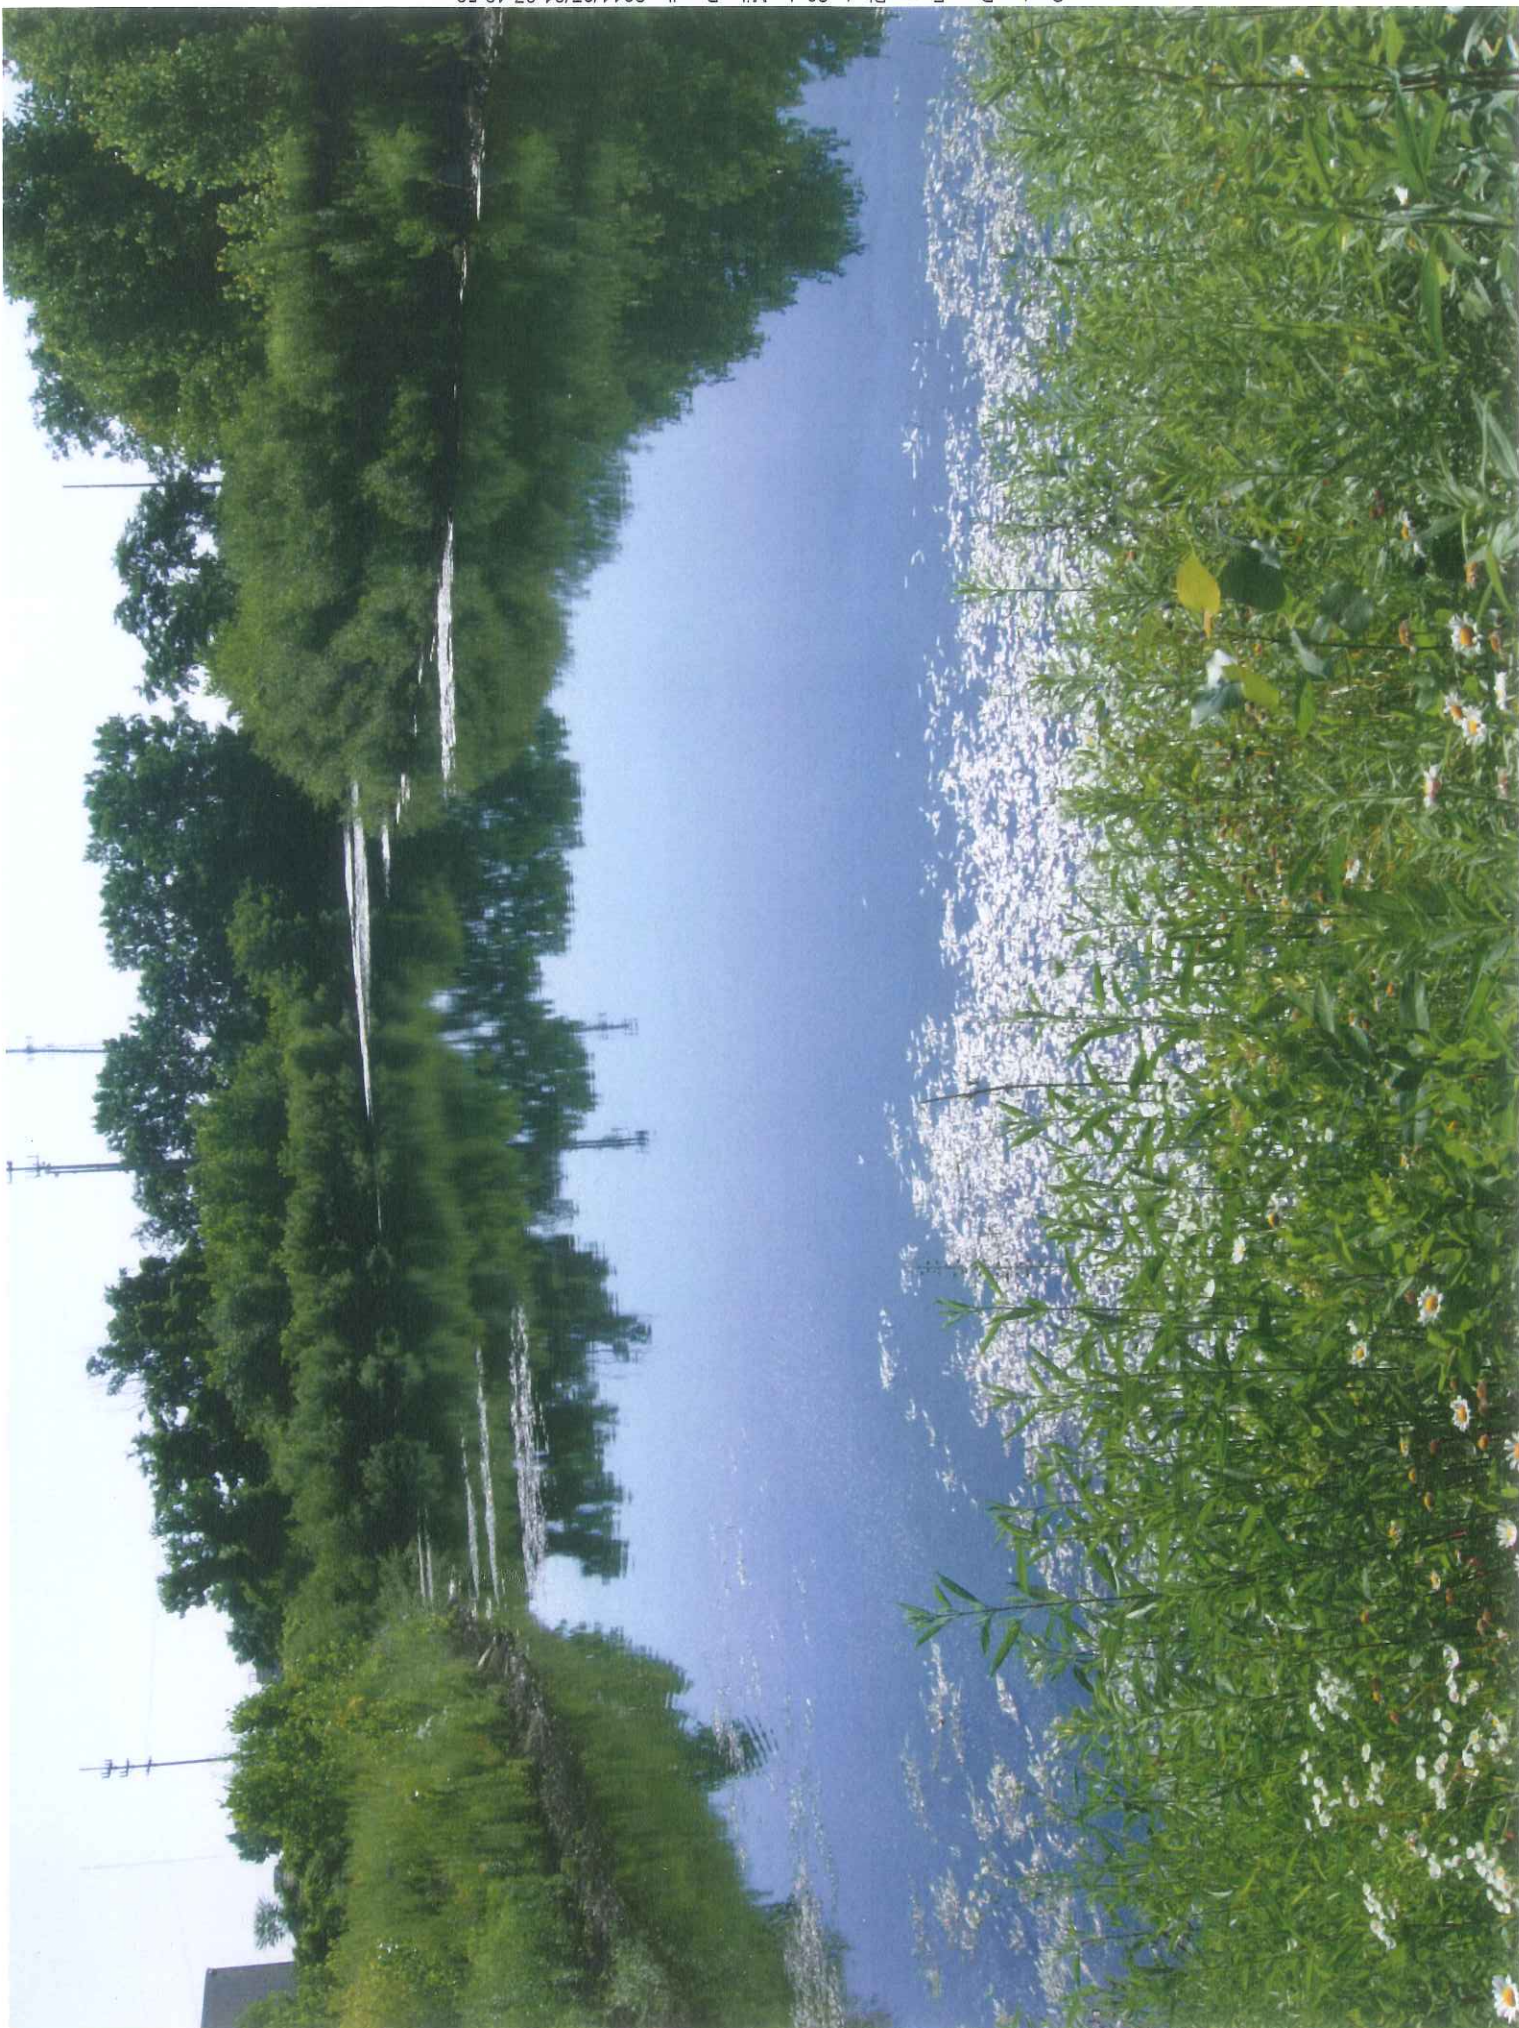
Canton Drop Forge Photo 28, by Mike Beedle, 2011/07/01 07:49:59

| Photo | Description |
|---|--|
| 28 | Pond 3, looking east from west bank. |
